Dynamic Tests Of Metal Beam Guardrail

**DYNAMIC TESTS OF METAL
BEAM GUARDRAIL**

CA-DOT-TL-6392-5-75-04

"Dynamic Tests of Metal Beam Guardrail - Series XXVII"

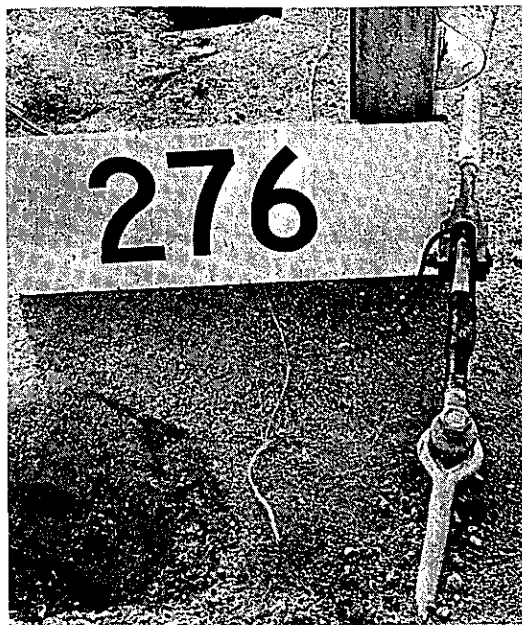
Figure 2
Cable End Anchor Used
on Barrier for Test
276

Figure 2 shows the cable end anchor with a swaged fitting (replacing the cable clips) which was used in Test 276. Note the strain gages that were used on the anchor for Test 276.

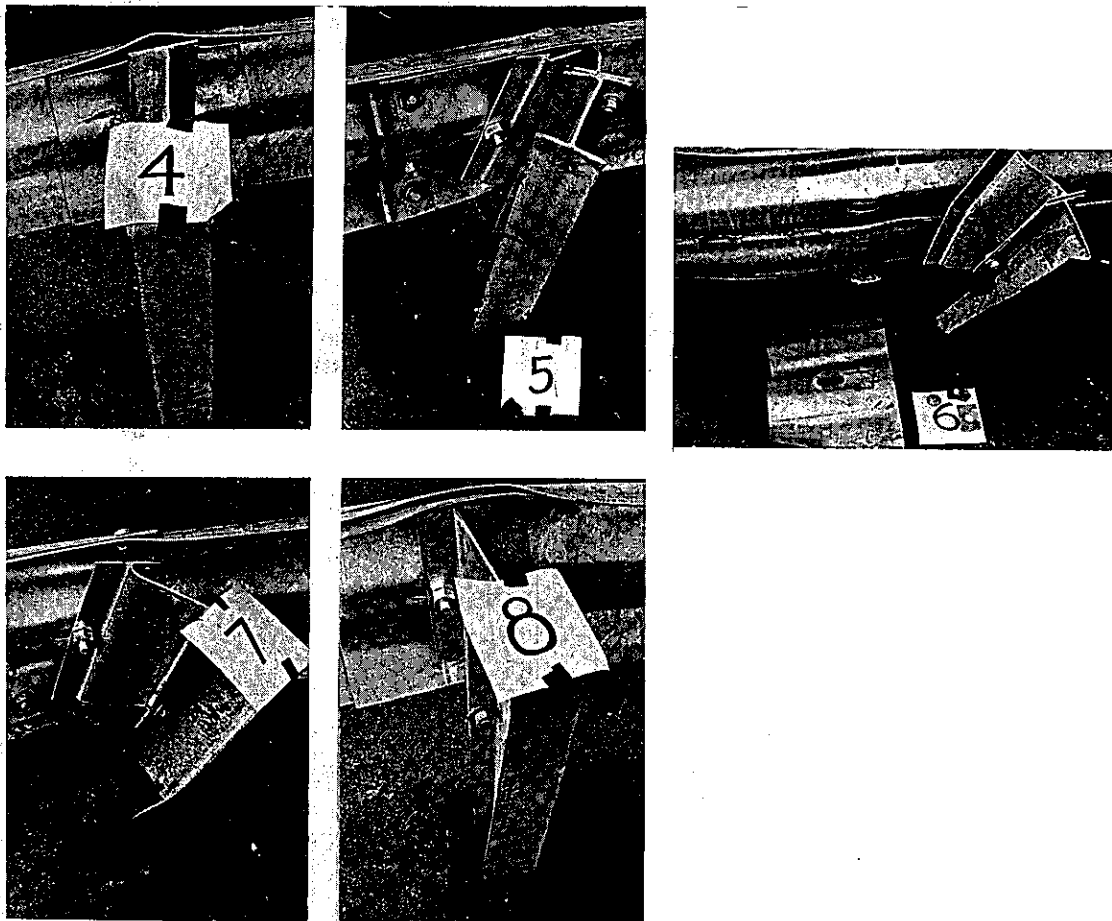
Figure 4 Barrier Damage, Test 276

Barrier damage consisted mainly of moderate twisting and bending of posts #5, #6, and #7 although none of the posts were bent to the ground. Separation of the metal beam guardrail from the

steel post block occurred only at post #6. Severe buckling of the blocks occurred at posts #5, #6, and #7. A maximum of 3/8" (9.5 mm) slippage of a beam splice occurred at post #5. Barrier damage is shown in Figure 4.

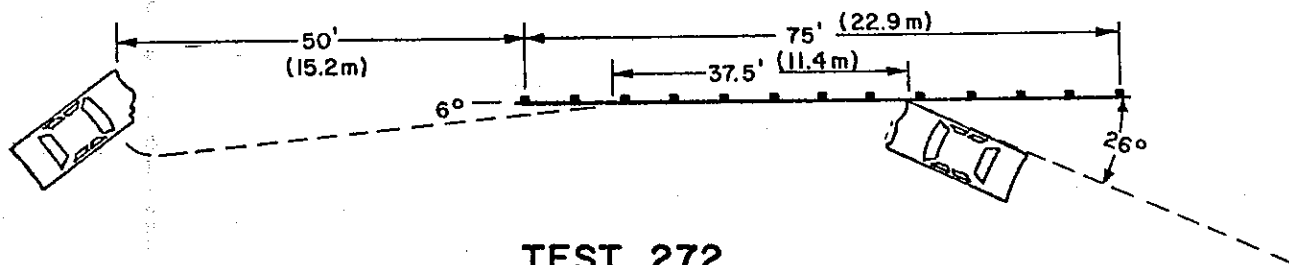
TEST 272

Figure 5 shows the test vehicle paths after impacting the test barriers. There is no easy answer to explain the variance in post impact trajectories. Various factors may have an effect including barrier deflection, vehicle crush and damage to the wheel, time when brakes are actuated by remote control, amount of rise and roll, paving surface conditions, etc.

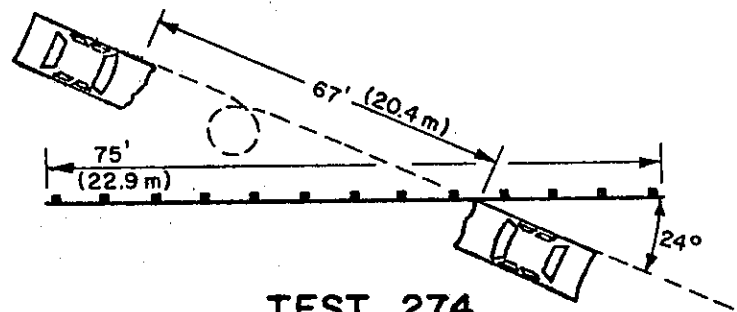
TEST 274

The vehicle penetrated the barrier with little change in direction and spun around 180° as it slid to a stop. There was no rise and very little roll imparted to the vehicle during impact. Figure 3 shows sequential photographs of the impact event.

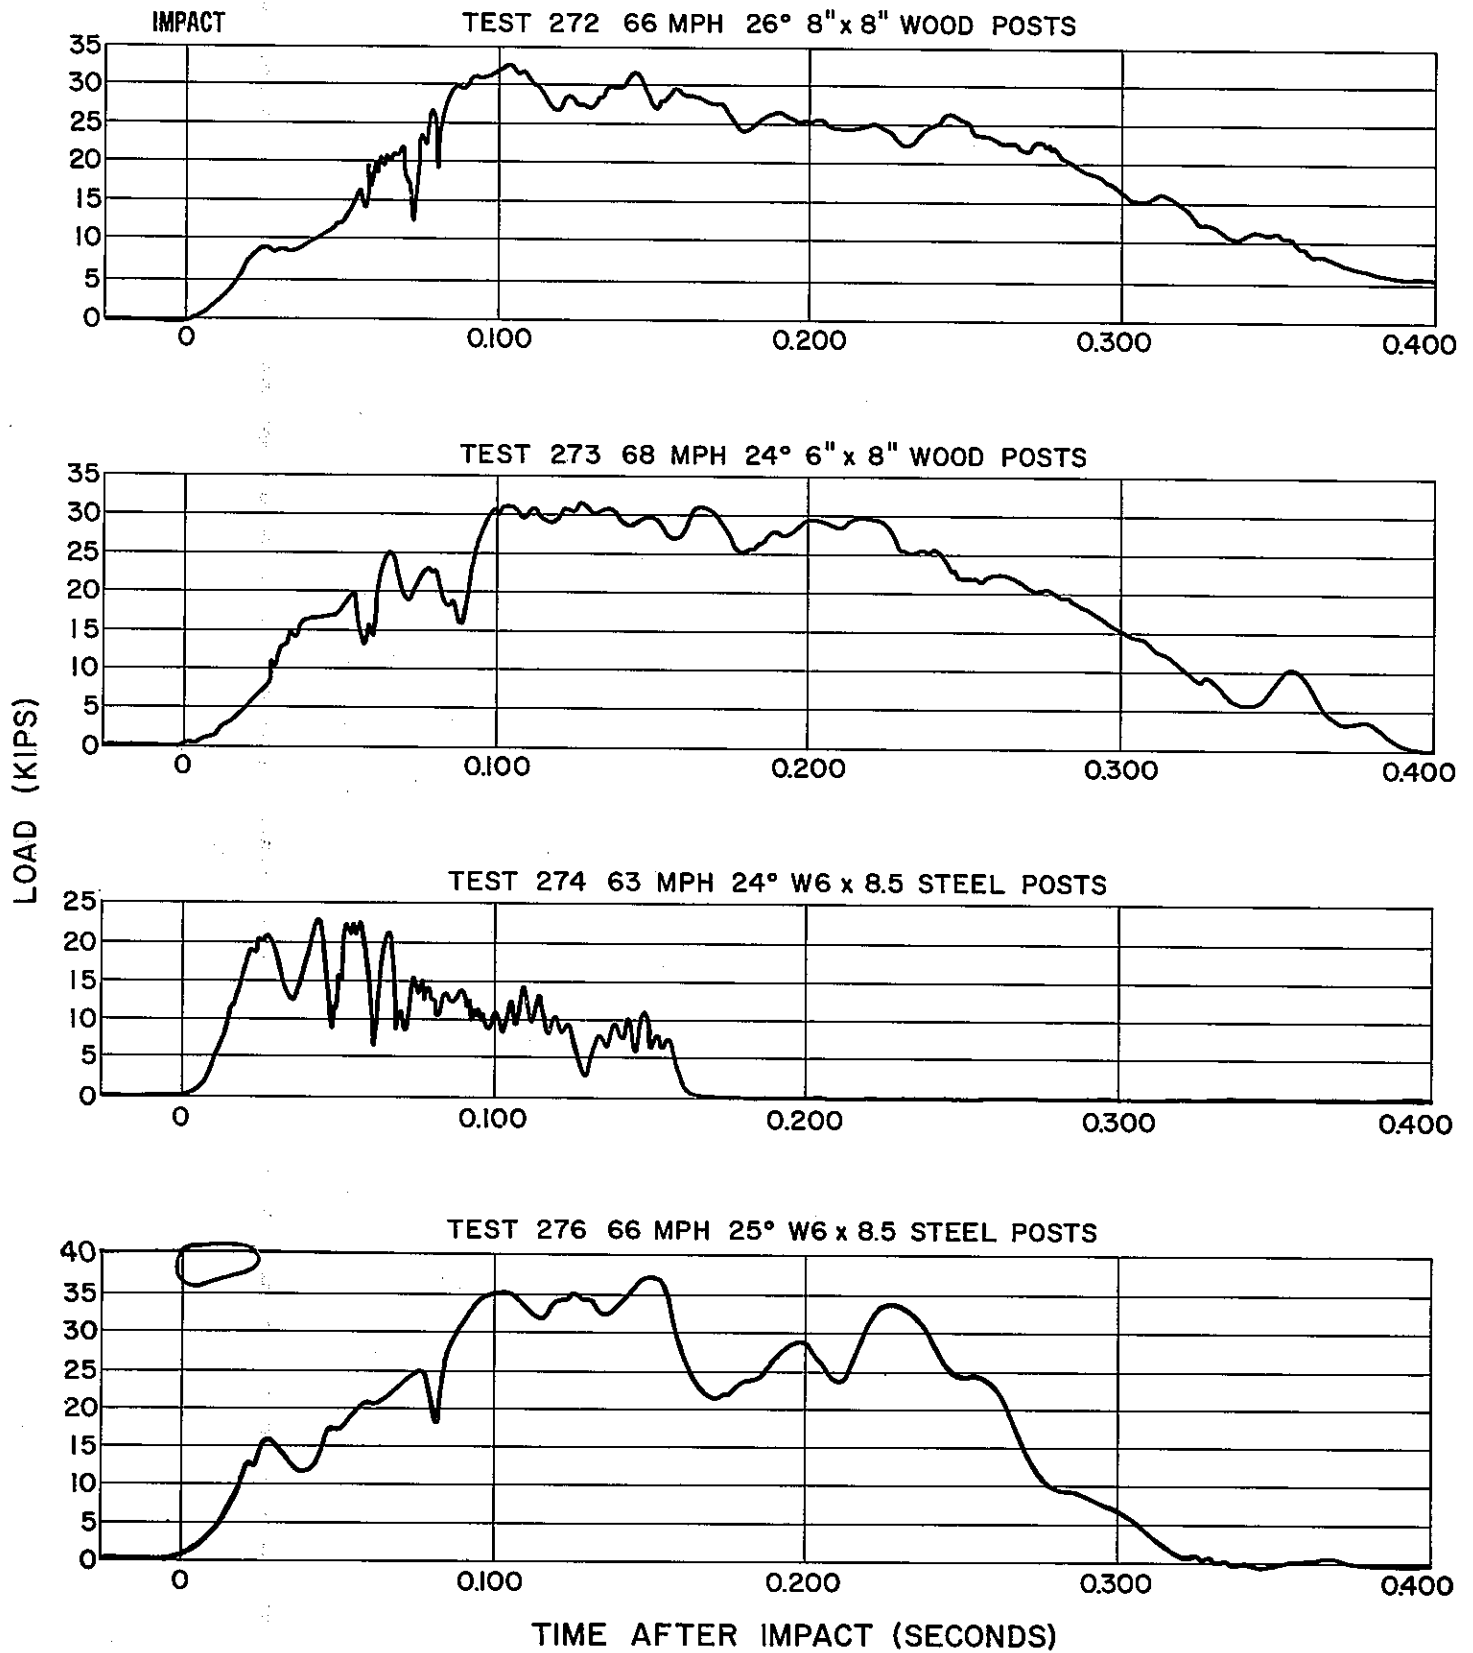
Figure 6 UPSTREAM ANCHORAGE
LOAD VS TIME

Figure 6 shows the loads on the anchorage cables during impact. They indicate more rapid load initiation times for Tests 274 and 276 where steel posts were used. They also show the cables are not overdesigned.

To correct this condition, two changes were made to the barrier design for Test 276; (1) a swaged fitting and clevis were used to replace the five cable clips on the cable end anchorage to provide a positive anchorage and (2) twelve inch long backup sections of W-section beam were placed behind the beam at alternate posts where beam splices did not occur. These backup sections reduced the tendency of the rail to hinge or tear along the hard sharp edge of the steel blocks and posts. The results of Test 276 proved the effectiveness of these modifications.
